PHOTOGRAPHS
M.V. "LEON I"
Wire Rope Inspection
@ Chesapeake Engineering & Design, Inc.
Annapolis, Maryland
October 8, 2003
Our Case No. WT-21833

M.V. "LEON I"
Wire Rope Inspection
@ Chesapeake Engineering & Design, Inc.
Annapolis, Maryland
October 8, 2003
Our Case No. WT-21833

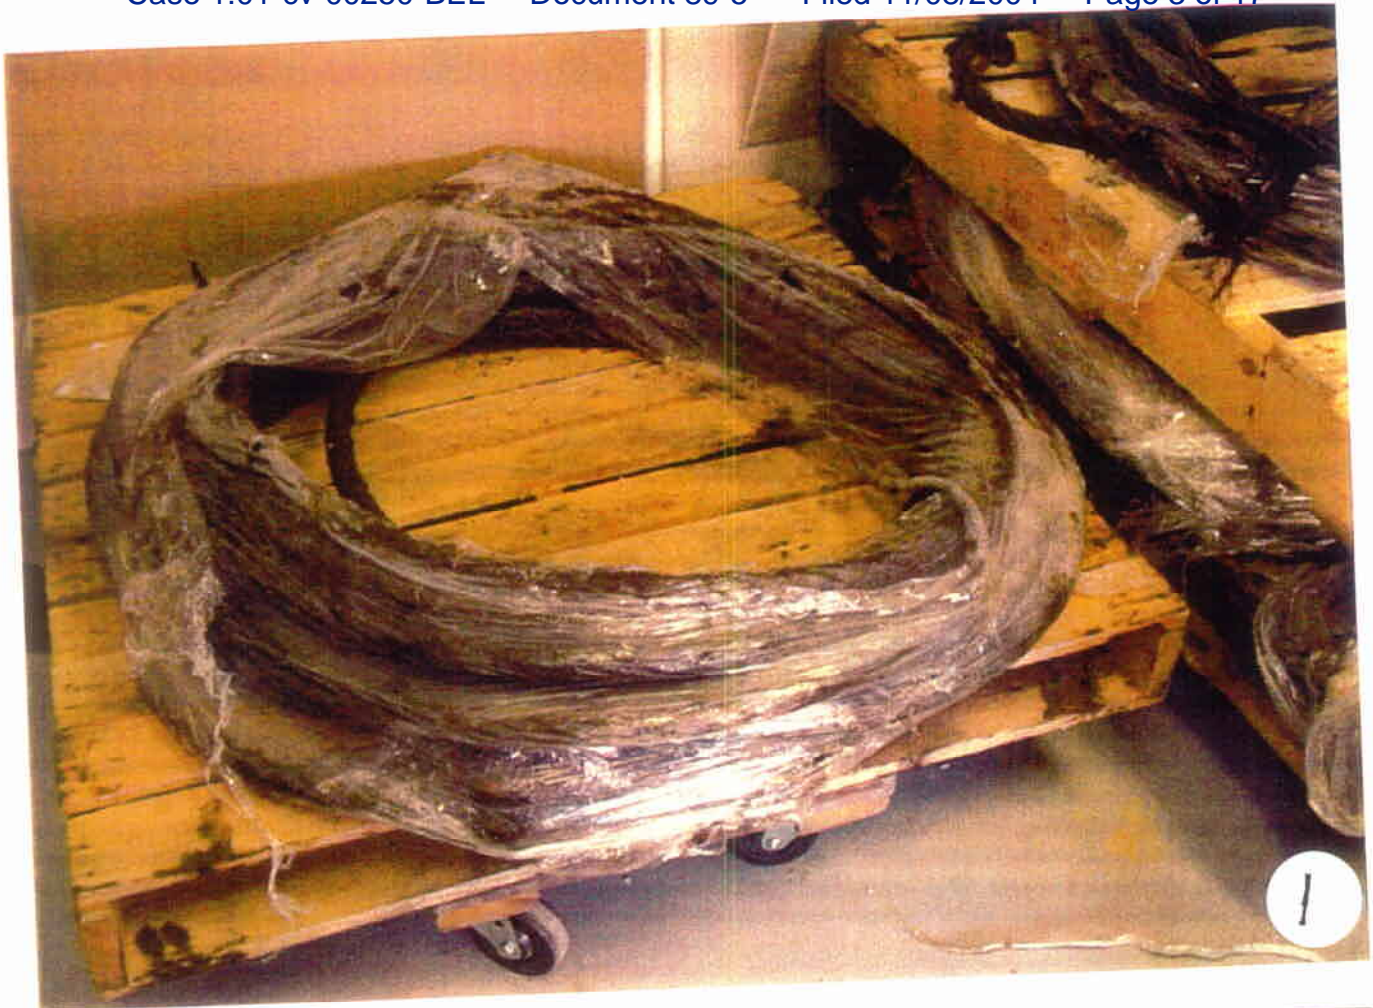
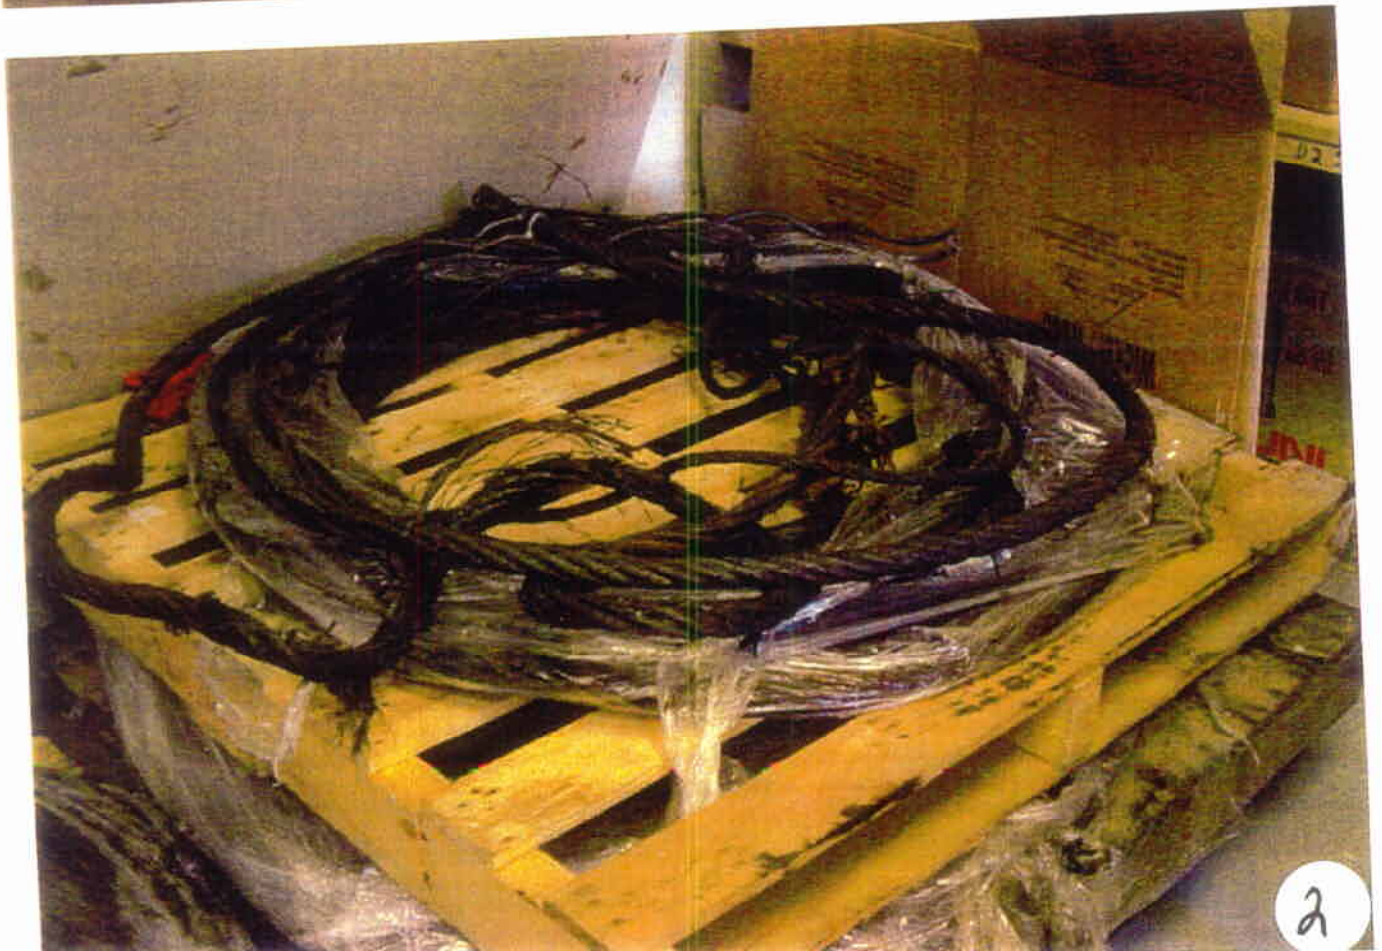
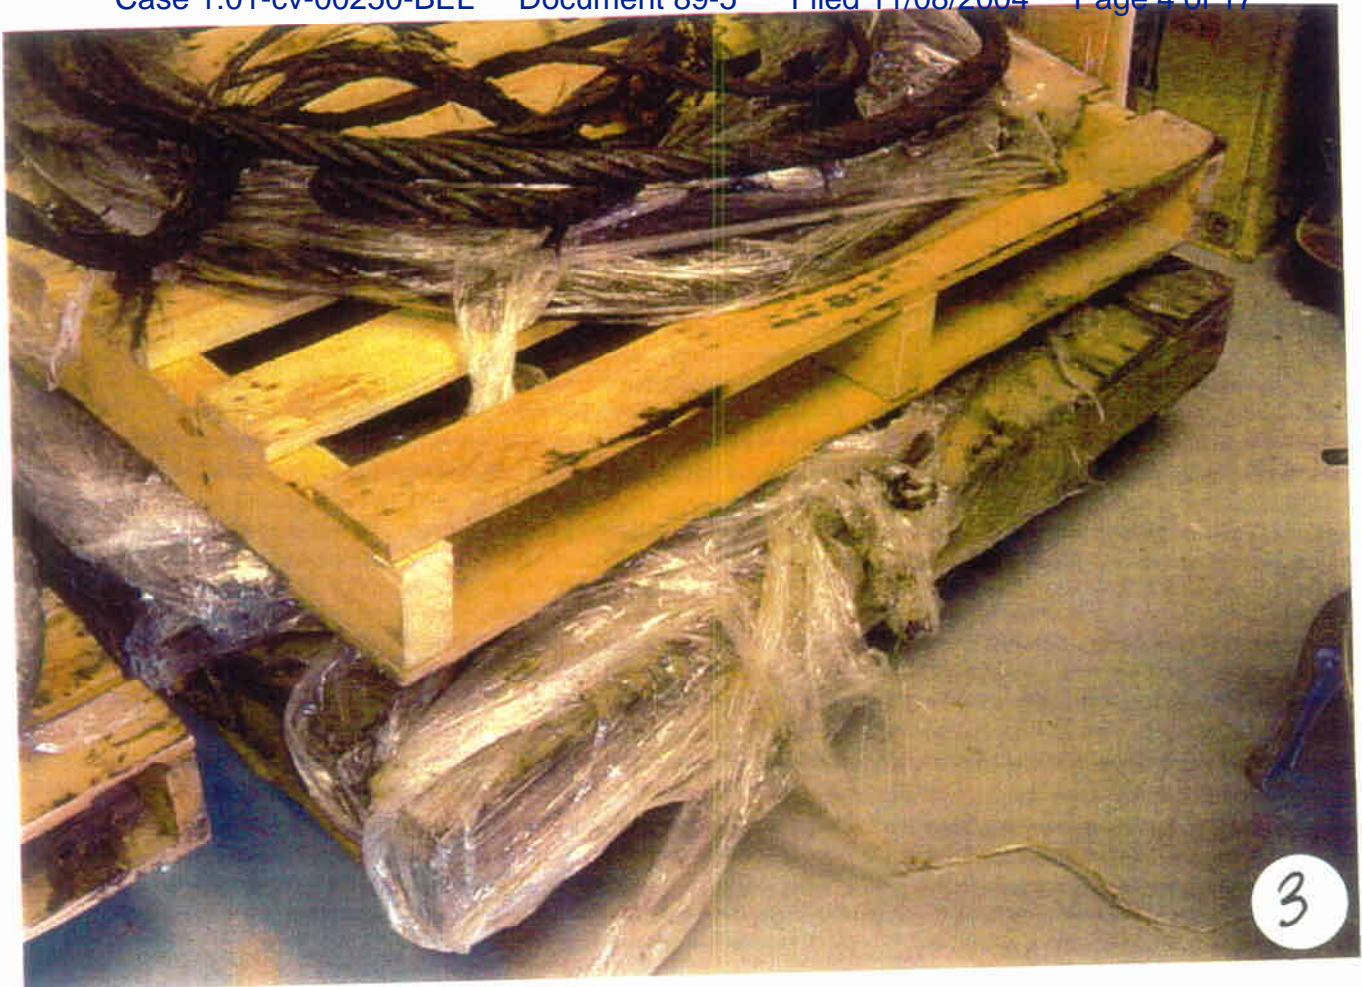
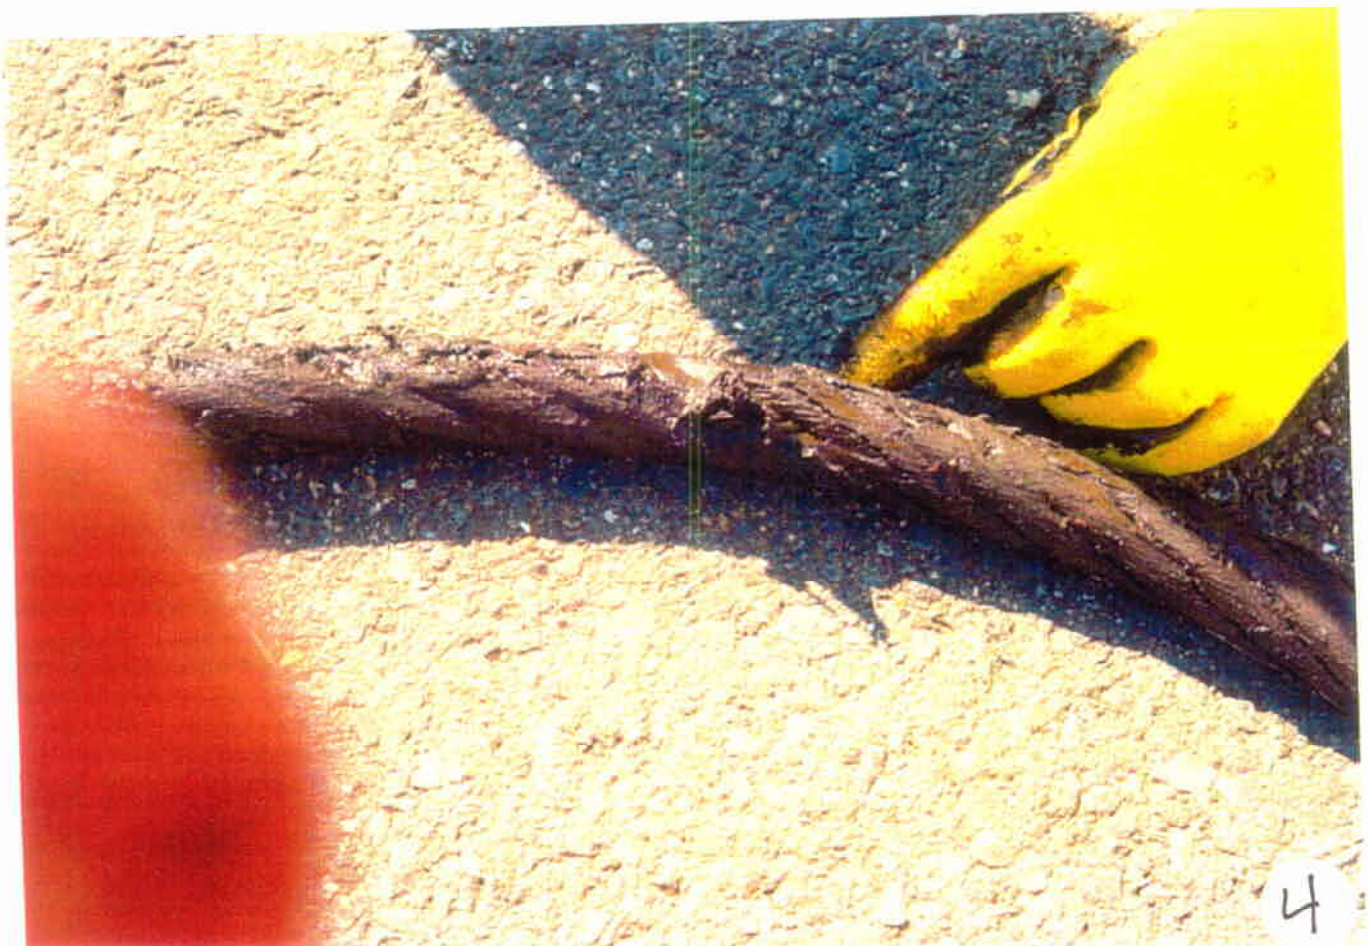
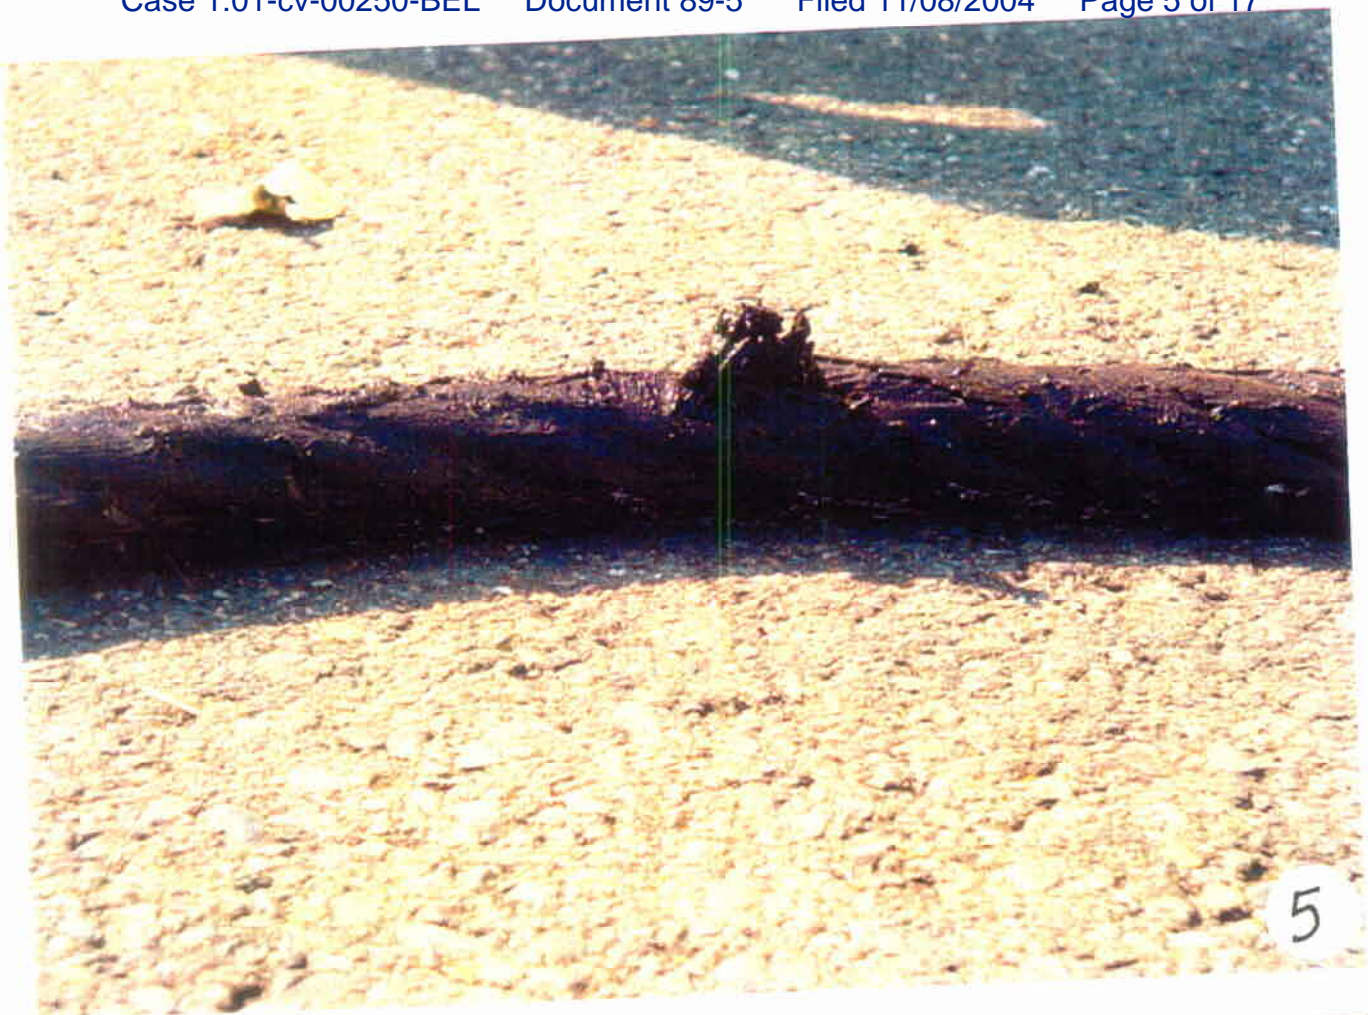
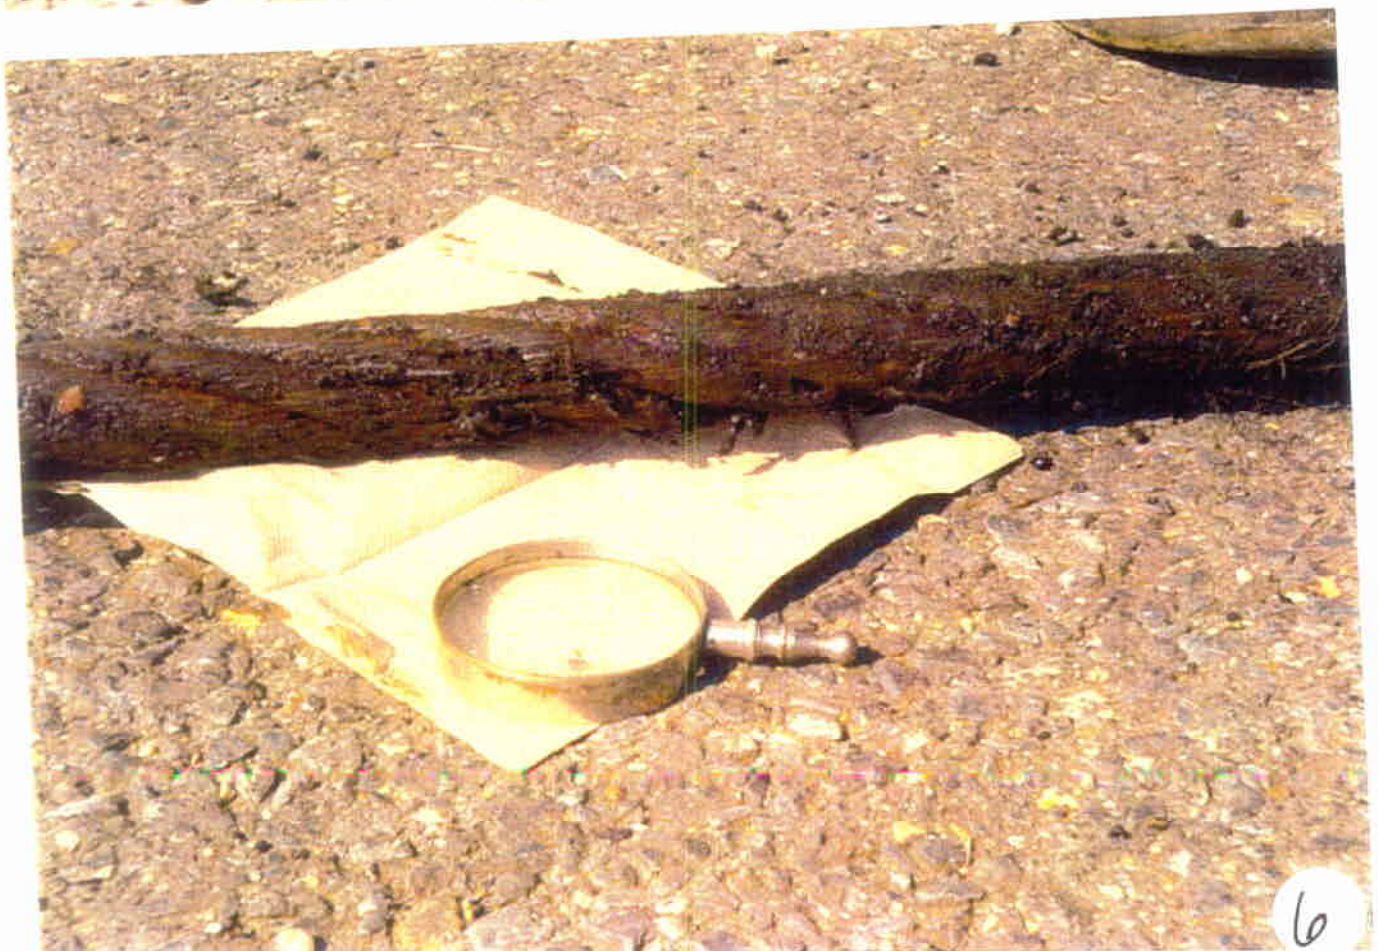
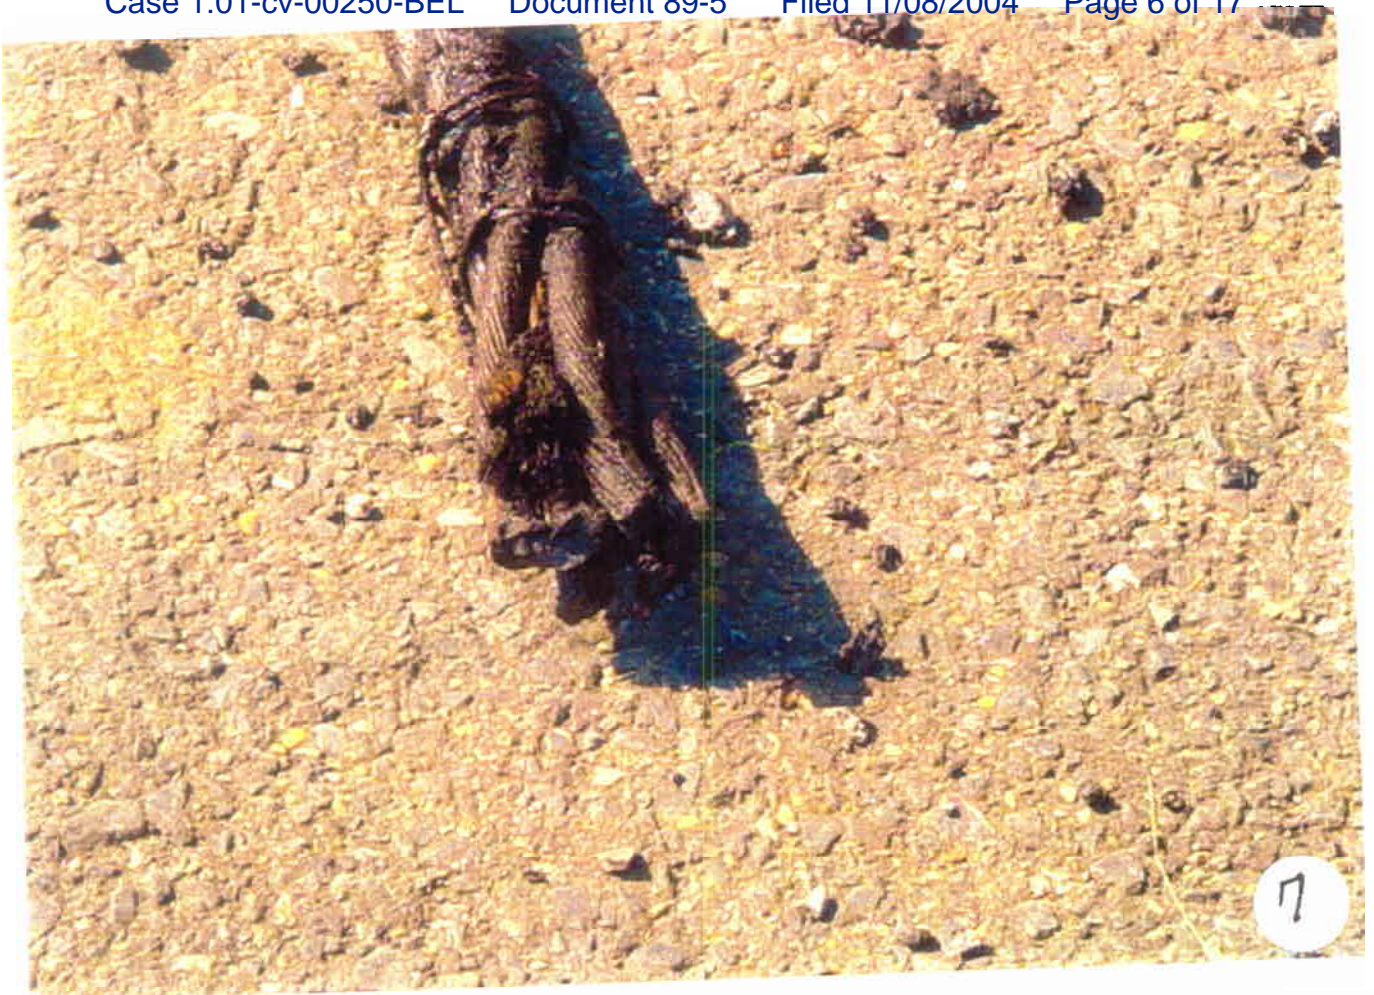
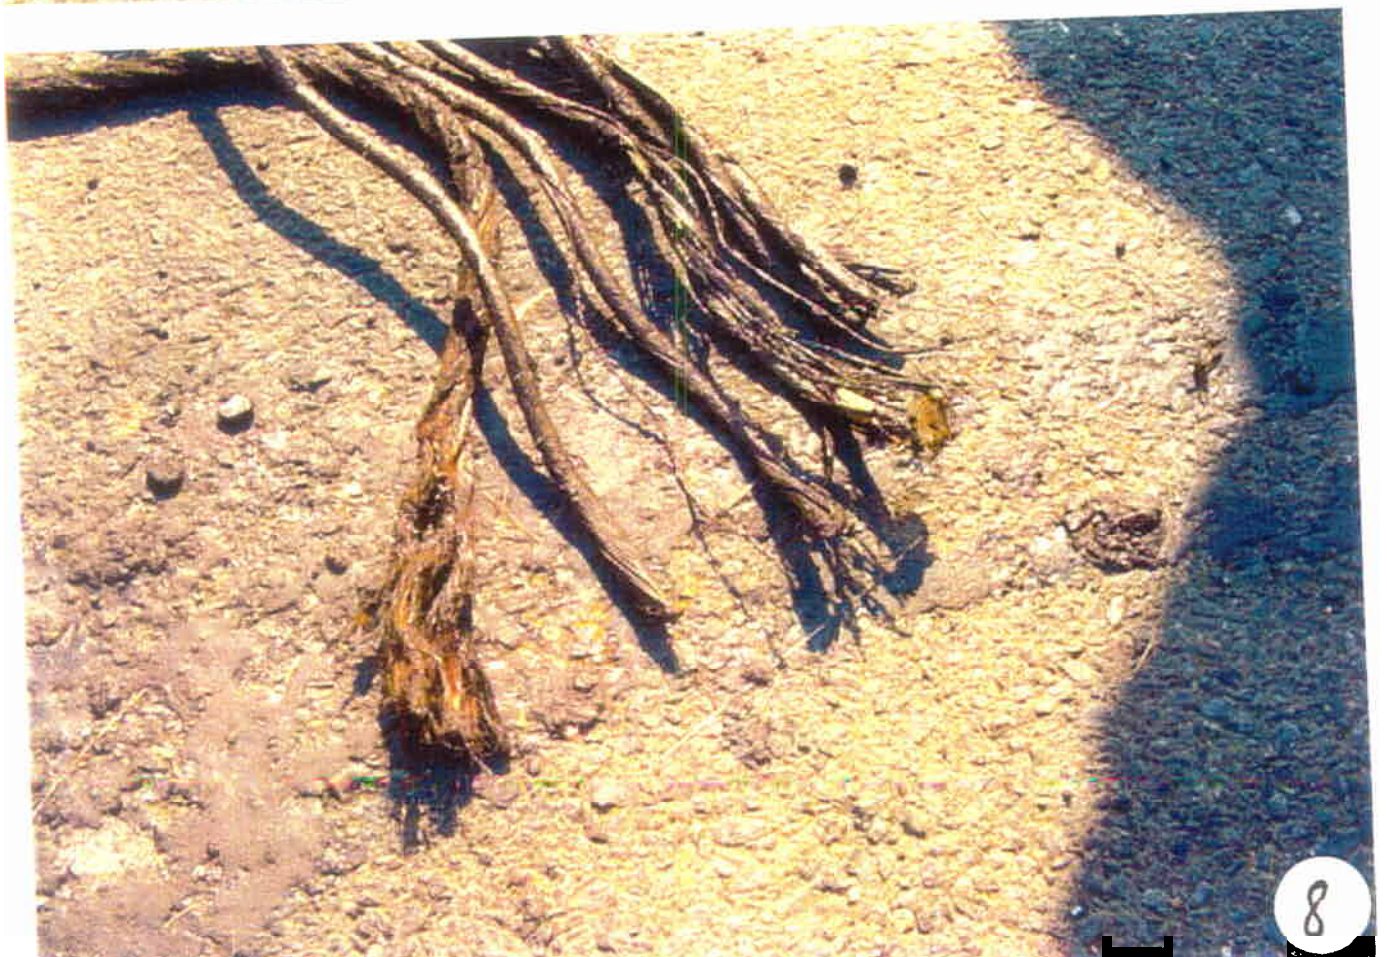
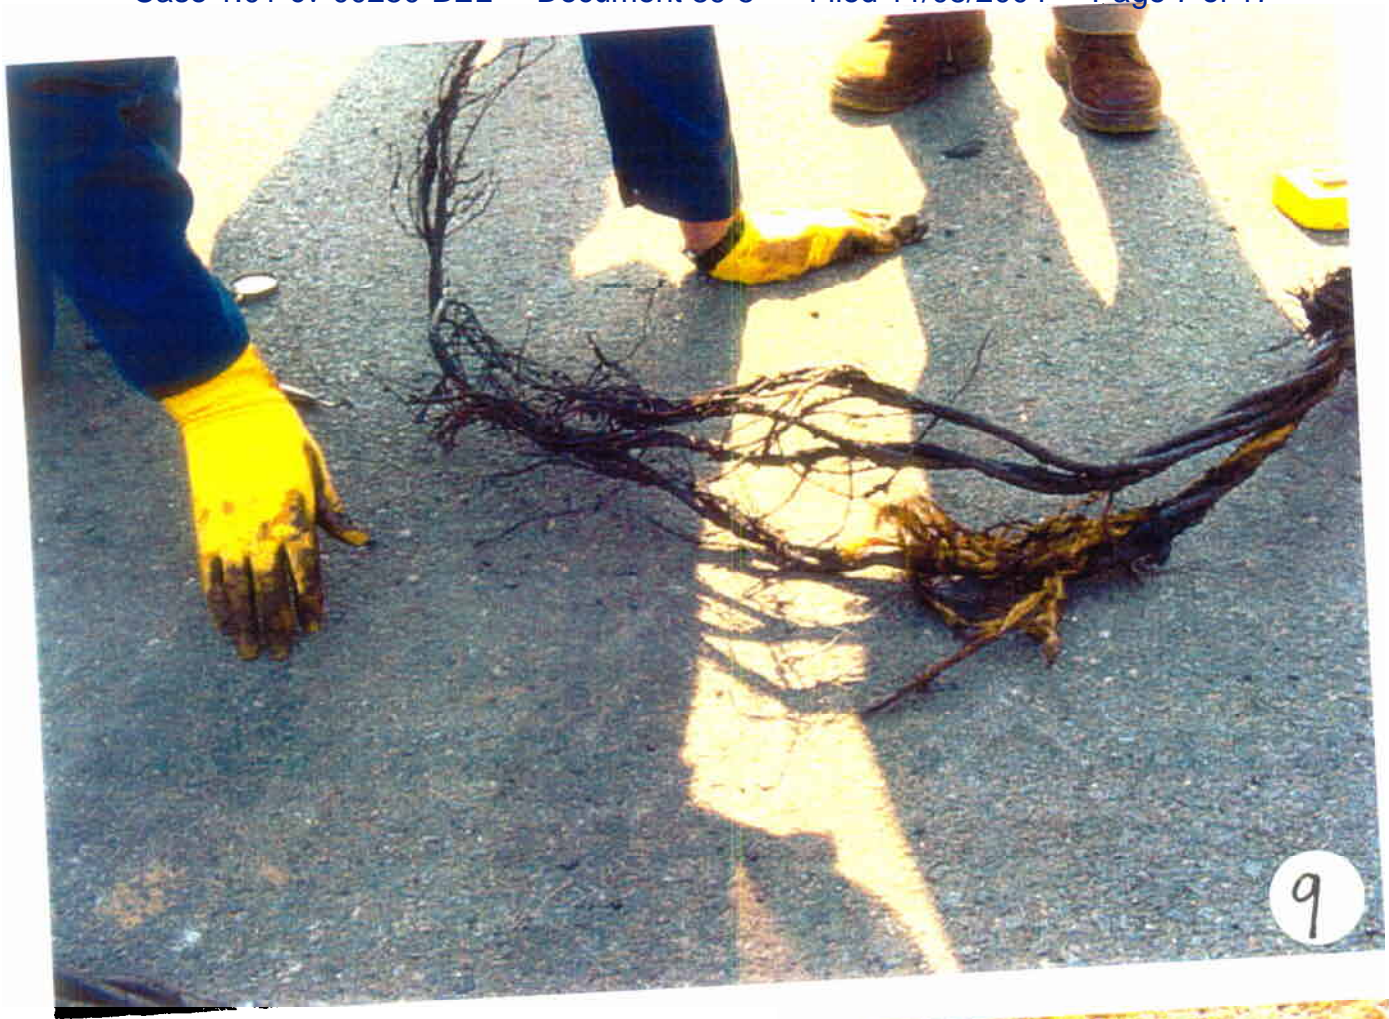
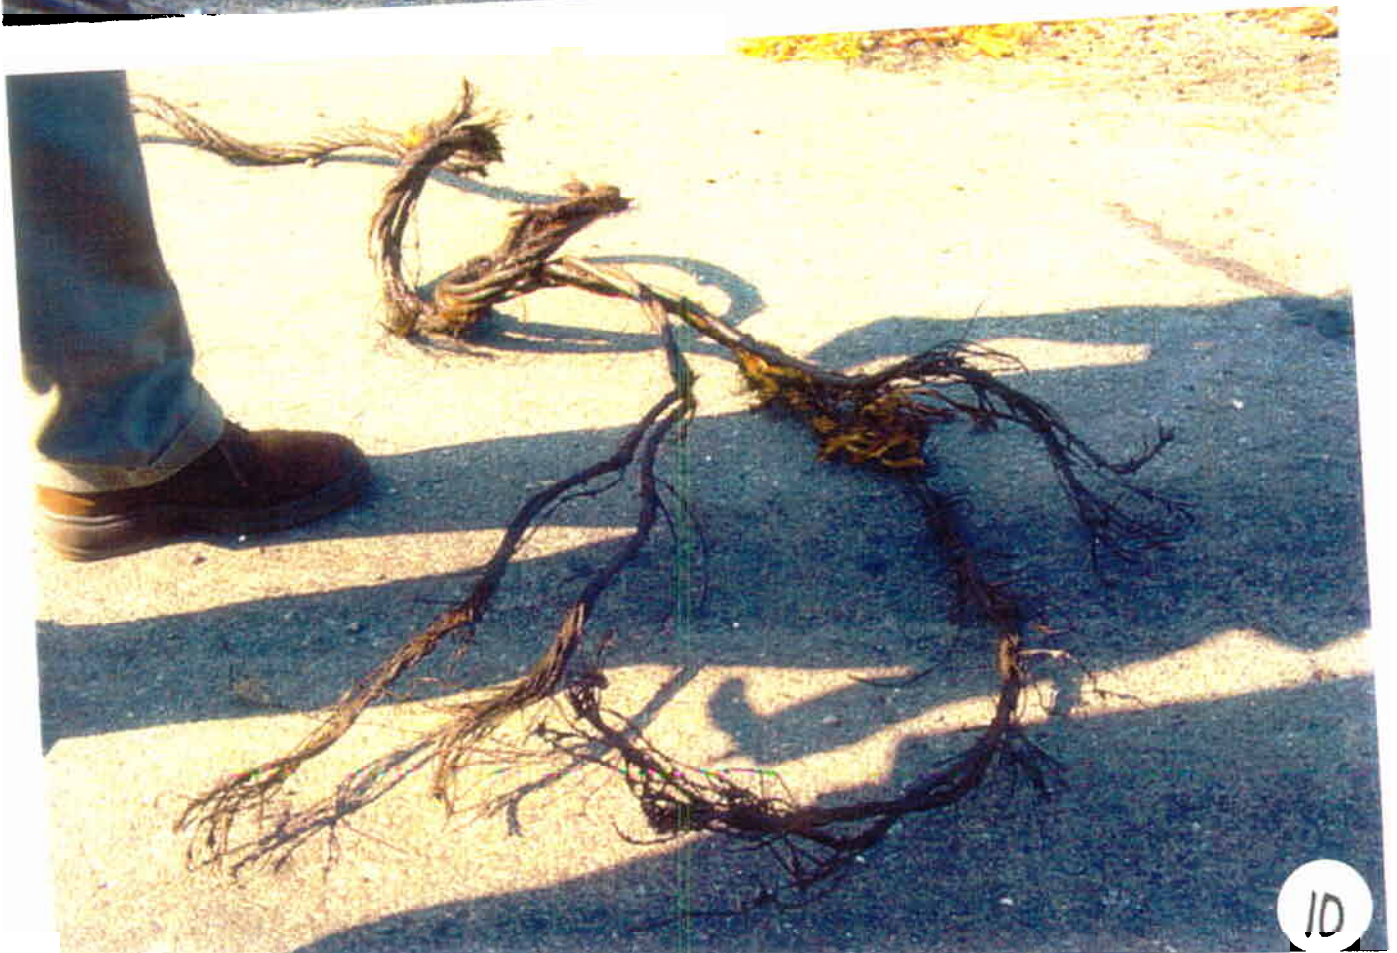
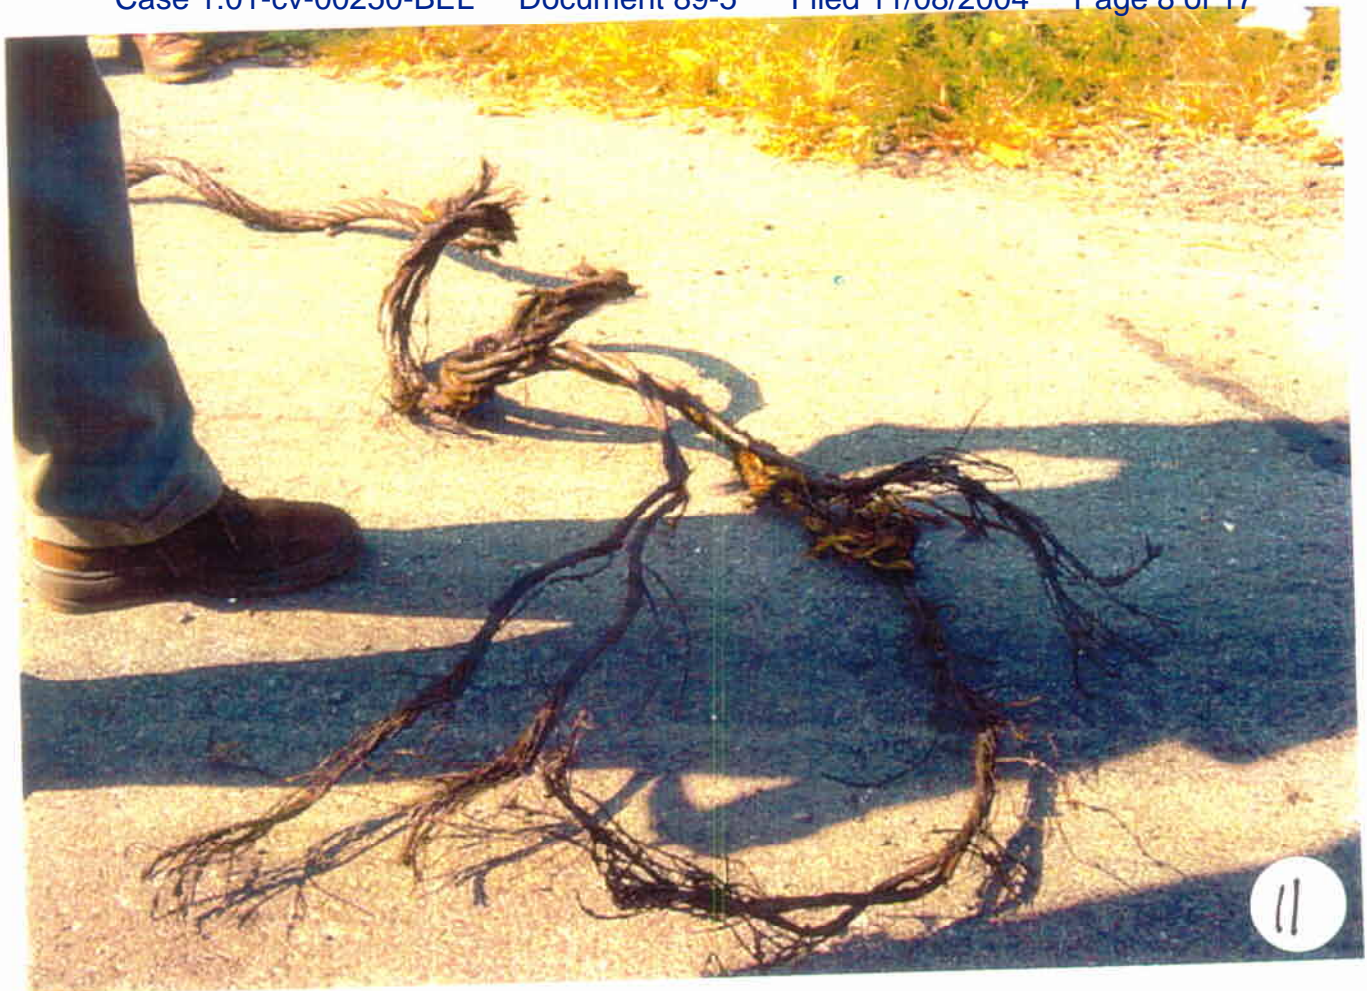
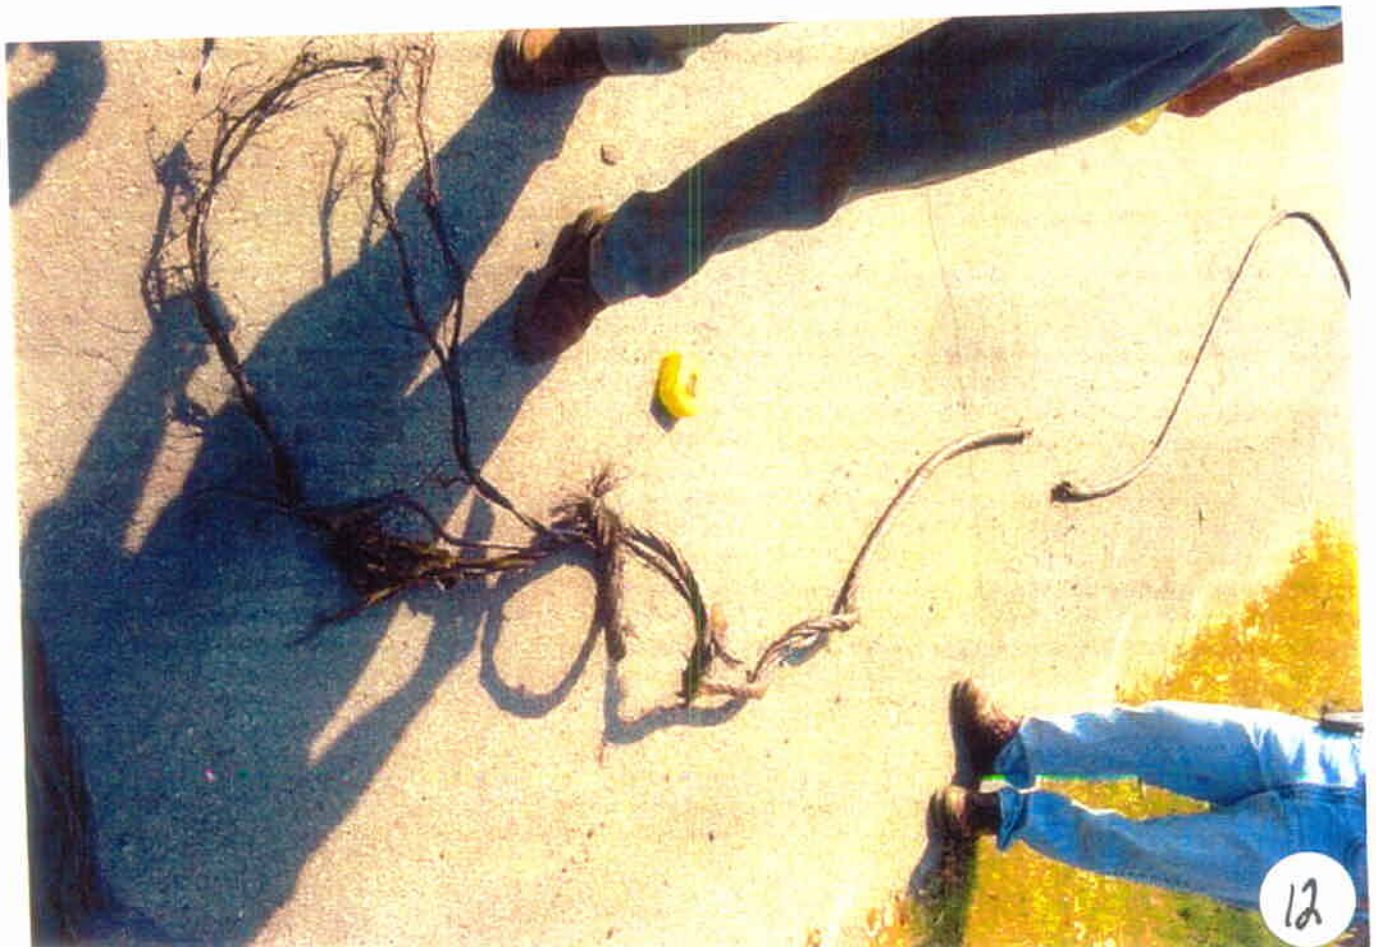
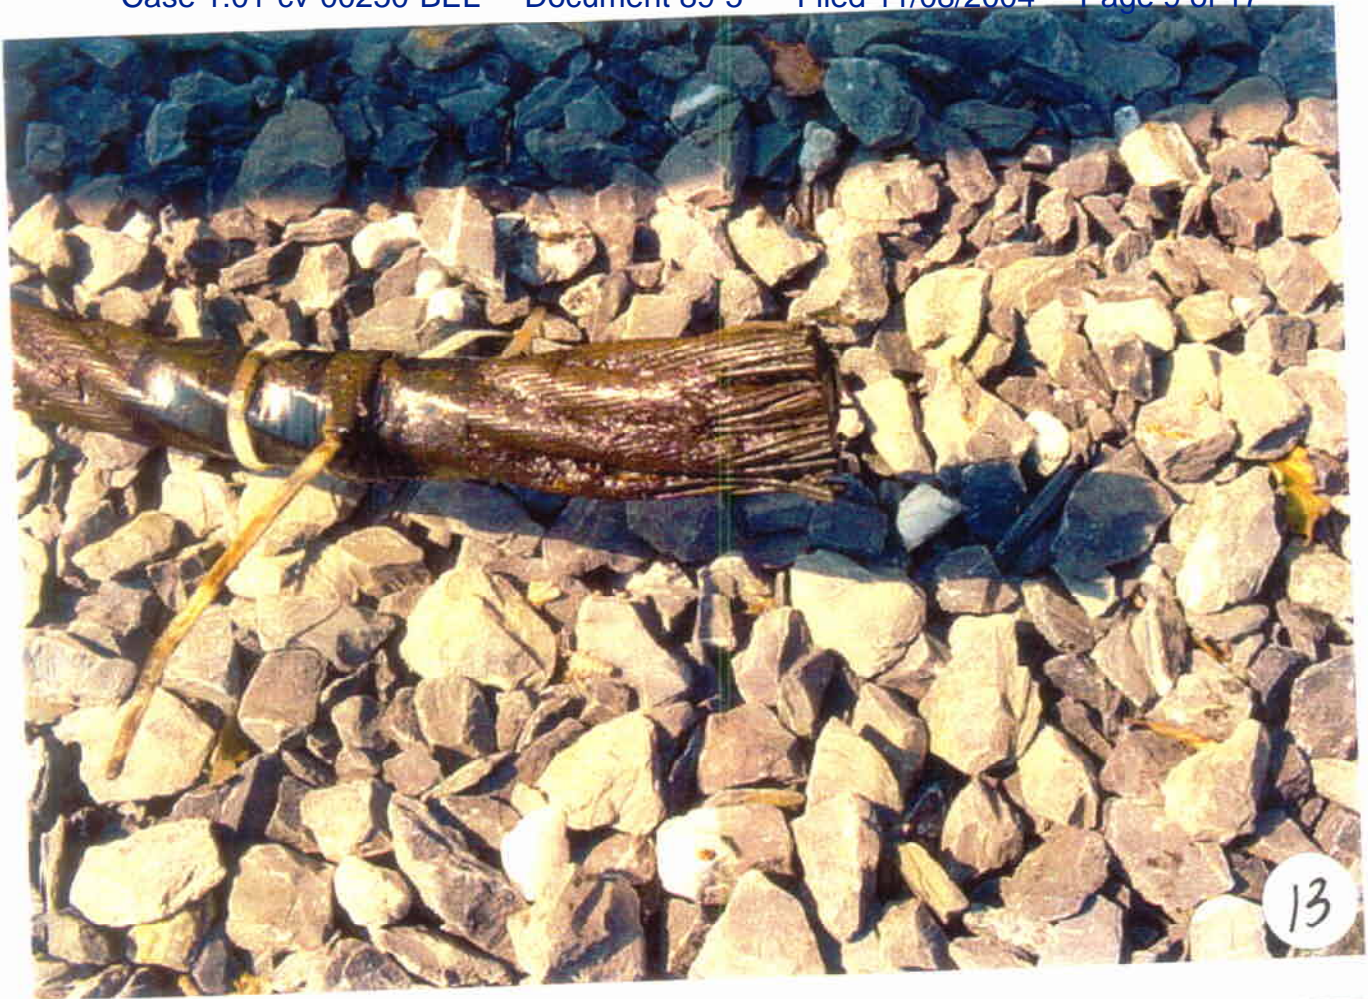
- 1) As stored on pallets
- 2) As stored on pallets
- 3) As stored on pallets
- 4) Local wire break
- 5) Local wire break
- 6) Local wire break
- 7) Cut end of wire rope
- 8) Frayed end
- 9) Part of failed section
- 10) Part of failed section
- 11) Part of failed section
- 12) Part of failed section
- 13) Cut end (possible where test piece taken)
- 14) Typical tensile break
- 15) Typical tensile break
- 16) Intermediate section of wire rope
- 17) Broken strand
- 18) General condition of wire rope
- 19) General condition of wire rope
- 20) General condition of wire rope
- 21) General condition of wire rope
- 22) Cut ends (not failure)
- 23) Failed area of wire rope
- 24) Failed area of wire rope
- 25) Failed area of wire rope
- 26) Taking a sample strand in area of failure
- 27) Area of failure
- 28) Area of failure
- 29) Area of failure
